ANALYSIS OF TECHNICAL CONDITION ASSESSMENT OF GAS TURBINE BLADES WITH NON-DESTRUCTIVE METHODS

Abstract: Structural components of gas turbines, particularly the blades, sustain a variety of damages during the operation process. The most frequent cause of these damages are the overheating and thermal fatigue of the material. A primary technique to assess condition of the blades is the metallographic examination. In spite of the fact that metallographic analysis delivers much more information on the structure of examined blade material, it is a type of destructive test resulting in the destruction of the blade which makes further utilization of the item impossible. The paper has been intended to discuss non-destructive testing methods and to present capabilities of applying them to diagnose objectively changes in the microstructure of a turbine blade with computer software engaged to assist with the analyses. The following techniques are discussed: a visual method, based on the processing of images of the material surface in visible light, active thermography, based on the detection of infrared radiation, and the X-ray computed tomography. All these are new non-destructive methods of

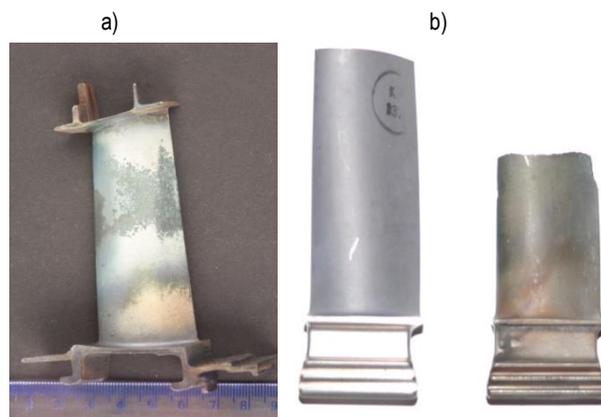
Fig. 1. a) – a vane with overheated area, b) – an image of the blade clipped due to overheating (Błachnio and Kułasza, 2009; Błachnio, 2011)

in which it is embedded. The main causes of a gas turbine's damages are its overheating and thermal fatigue (Fig. 1).

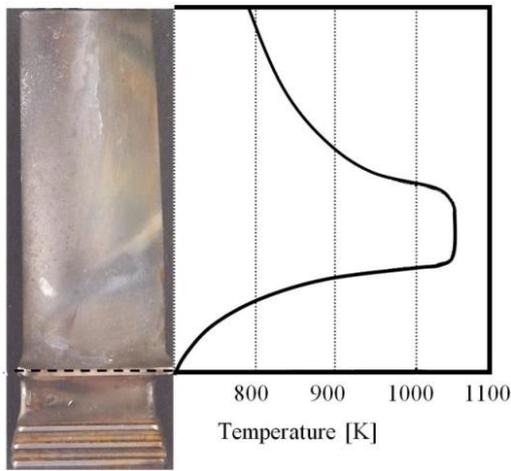
Fig. 2. A diagram of the typical temperature distribution along the gas turbine blade feather (Błachnio, 2011)

maximum temperature on a given blade. A typical temperature distribution along the blade feather is very uneven (Fig. 2). Damages to the first (central) stages of a turbine are usually caused by the impact of high temperature of exhaust, whereas damages to the last, (peripheral) stages (turbines with the longest blades) originate mainly from the effects of mechanical strain (vibration, centrifugal force) (Błachnio, 2011; Karczewski, 2008; Szczepanik and Rządkowski, 2012; Marsh, 2013).

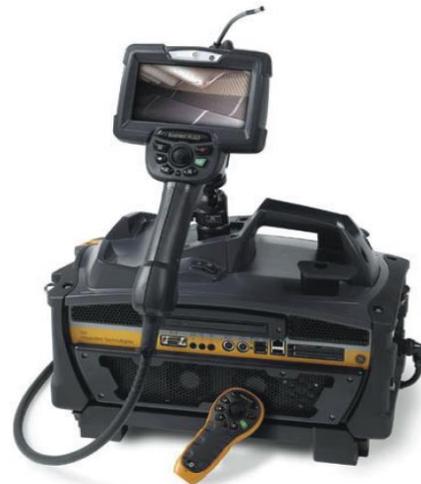
Fig. 3. Optoelectronic device – videoscope (EVEREST XLG3-Video Probe. 2006)

Illuminated surface of the blade can be recognized by a light-sensitive detector (CCD matrix with an optical system – optoelectronic system) through a secondary source of light from its surface. CCD matrix counts incident photons, energy of the light rays incident on each pixel. In the case of a computer vision system the image is obtained from ambient by means of an optoelectronic device – videoscope (Fig. 3). This enables indirect method of diagnosis of the object through the processing and analysis of data collected in the form of digital images.

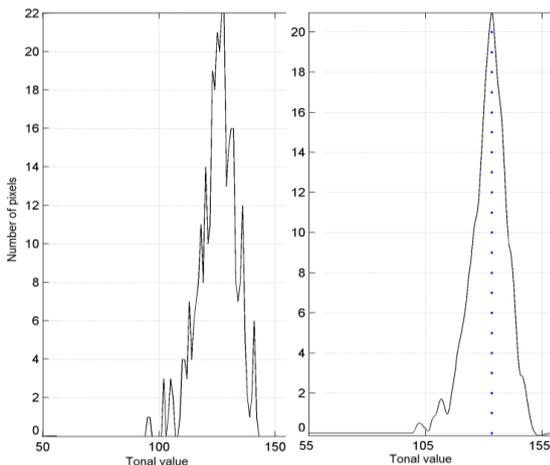
Fig. 4. Exemplary spectral analysis of the image of blade surface (Blachnio and Bogdan, 2010)

Parametric description of histograms is to determine the position of the maximum value of the amplitude, i.e. the number of pixels (ordinate axis) for the values of saturation of grayscale or RGB (abscissa axis) – Fig. 4. In order to extract diagnostic information the examined waveforms of the changes of the maximum amplitude values in the function of temperature are approximated by polynomials.

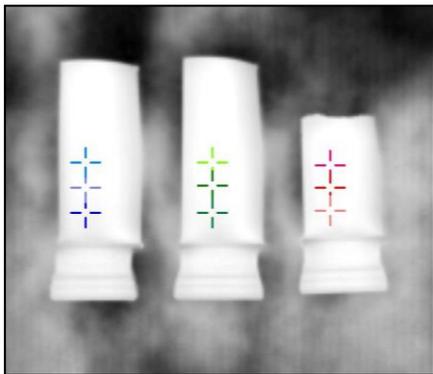
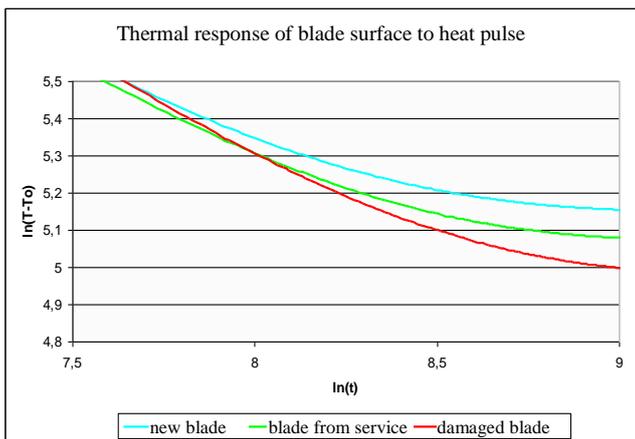
Fig. 7. Blades thermograph and changes of dependence of the parameter $\ln(T-T_0)$ of the thermographic signal at selected points of the blade surfaces (Kulaszka et al., 2011)

Thermographic examinations covered the turbine blades made of alloy EL-867WD, classified into various categories: new, used - fit and damaged during turbine engine operation. The obtained results confirmed changes of parameter dependence of thermal response of the examined blade materials to stimulating heat pulse (Fig. 7).

While on the basis of the analysis of the response to the heat pulse of the blade material classified as "unfit", it was possible to determine areas clearly deviating from the average value. These areas coincided with areas visually assessed as overheated which, combined with the results of the tests conducted on sam-

ples (Fig. 7) allows to draw conclusions on superheated structure of the material.

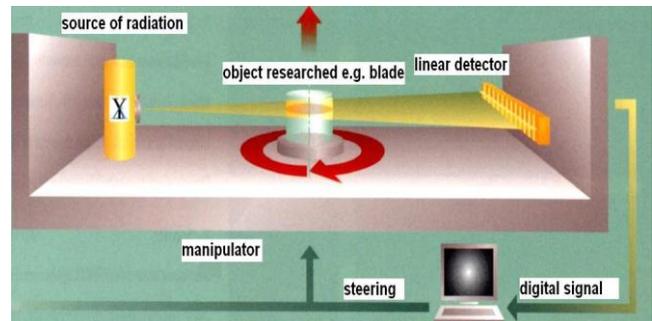
Fig. 8. The example of a tomography investigation with use of a linear detector (Electronic Instrument CT-X-ray, 2011)

Tomography is the collective name for the diagnostic methods aimed at obtaining a spatial image of the machine element. In the technical diagnosis, a method of computed tomography (called CT) has been widely applied (The research report, 2011). It is a kind of X-ray tomography allowing for obtaining spatial images (3D) from the radiograph scanning of the object performed from different directions (Fig. 8).

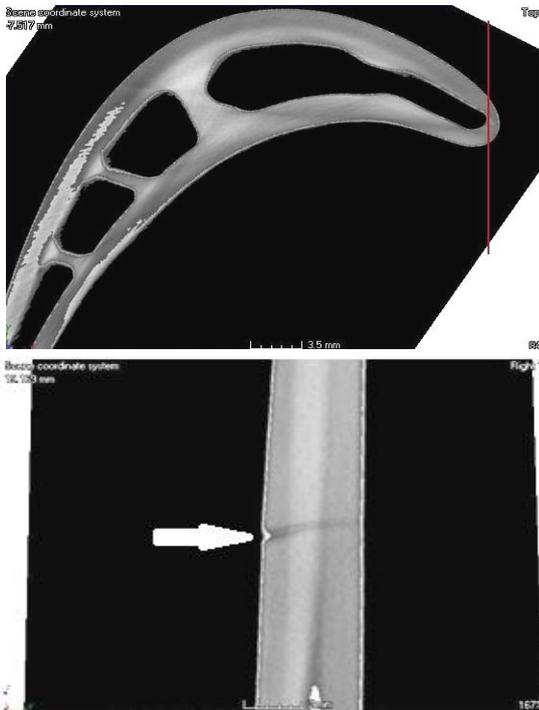
Fig. 9. Tomogram of a turbine blade with a visible crack at the leading edge (Chalimoniuk et al., 2013)

Computer radiography applied to turbine blades allows the observation of actual thickness of the inner, invisible walls (Chalimoniuk et al., 2010). An image of the object can be represented in the colours and the shape of the inner wall can be determined in the appropriate scale, e.g., the size and location of the defect. Also, the geometry of the internal components can be accurately measured and the tolerance of their actual dimensions be assessed. Thus, CT scan allows to verify the correctness of realization of the component with a very high degree of accuracy and diagnose internal damages, for example, cracks, blade canals blockage, etc. (Fig. 9).
